EARTHQUAKES AND BUILDING CONSTRUCTION

A Review of
Authoritative Engineering Data
and Records of
Experience

Published by CLAY PRODUCTS INSTITUTE OF CALIFORNIA
611 Architects Bldg., Los Angeles 116 Natoma Street, San Francisco

COPYRIGHT 1929 BY CLAY PRODUCTS INSTITUTE OF CALIFORNIA

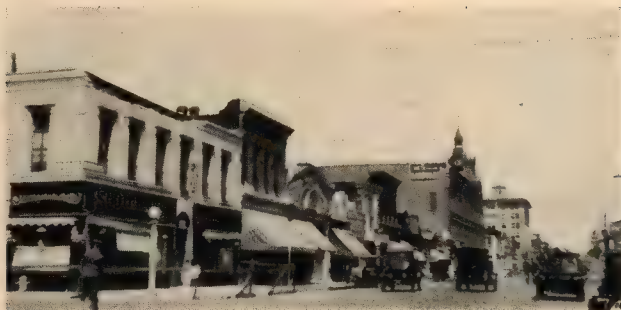
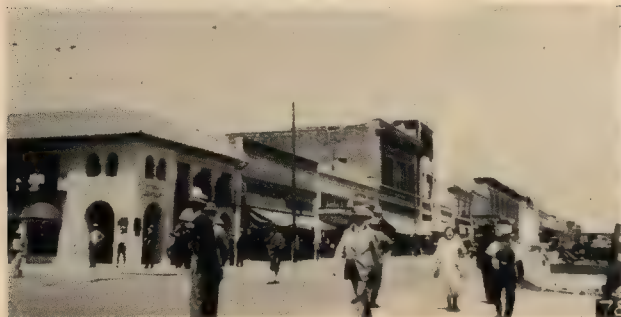
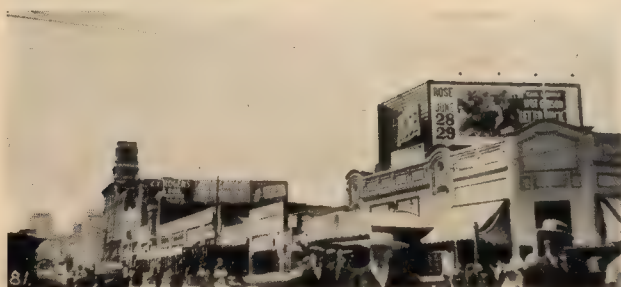
Nos. 70, 71 and 72—State Street scenes shortly after earthquake. Practically all buildings shown are brick bearing wall buildings. Notice small proportion of damage.

that were damaged. Out of many examples that might be chosen a few such examples are shown, Photographs 69, 70, 71 and 72.

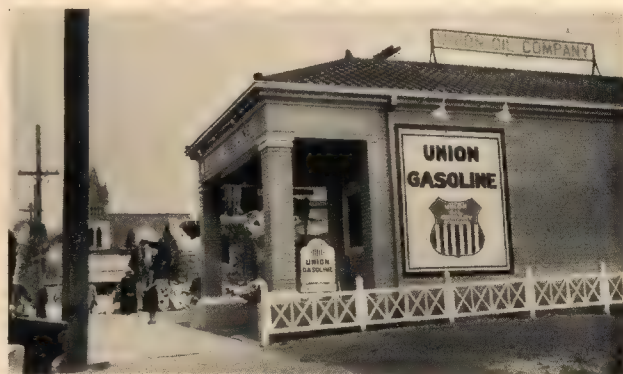
No. 74—Brick oil station, showing stability of this type of construction as against stone as demonstrated by wreck of church in background.

A particularly interesting case is the I. Magnin Building located right on the Arlington Hotel grounds where such serious damage occurred to an unsound building, Photograph 73. This was a two story brick building. It was undamaged, except a few plaster cracks. Illustrating the stability of the one story brick building of a type not dissimilar to the smaller brick residence is the gasoline station of the Union Oil Company, Photograph 74. That the earthquake was severe in this locality is evident from the wreck of the stone church in the background of the picture.

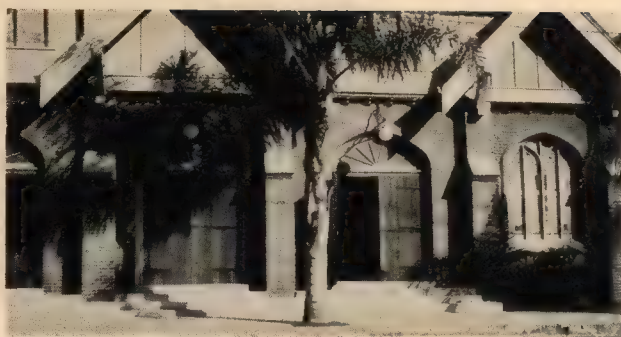
The First Baptist Church, Photograph 77, shows another example of beautiful and effective brick-work. There was merely a small crack on one corner of this building.

No. 77—First Baptist Church directly across Victoria Street from the Arlington Hotel.

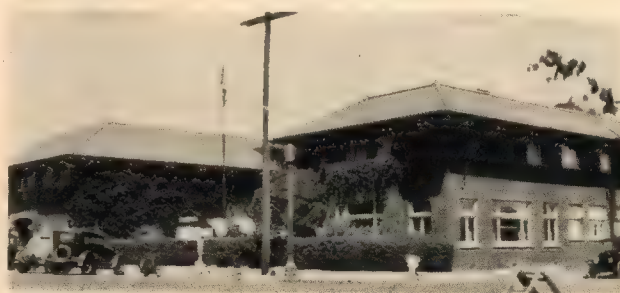
No. 78—Santa Barbara Recreational Center Building. Entirely unharmed. Located one block from the wrecked Arlington Hotel.

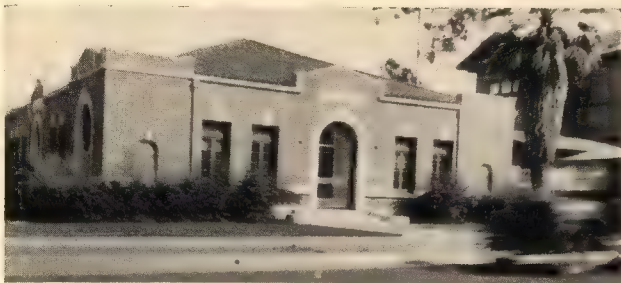
No. 79—School Administration Building. Brick bearing wall, face brick and tile construction. With the exception of the displacement of a few tile this building was in perfect condition.

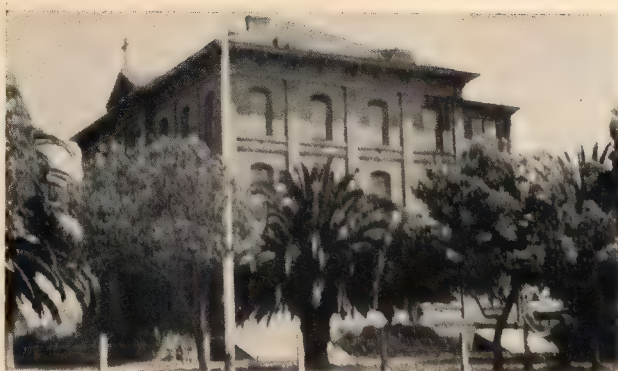
The photographic evidence may be concluded with a picture of the old St. Vincents Orphanage, Photograph 82. This hardy veteran was about 43 years old at the time of the disaster and had been condemned by city authorities as unsafe, nevertheless, it went through the earthquake entirely undamaged and no doubt arousing new respect by this worthy performance, was immediately reoccupied. It is a three and one-half story structure of old time brick work.

No. 82 — A Veteran Triumphant! The old Saint Vincent's Orphanage. Brick bearing wall building condemned before the earthquake as unsafe, but entirely undamaged by the shocks.
